Section 19 (Figure 19.1)
Case 1 : Water Table at RL +0.8m with long term parameters

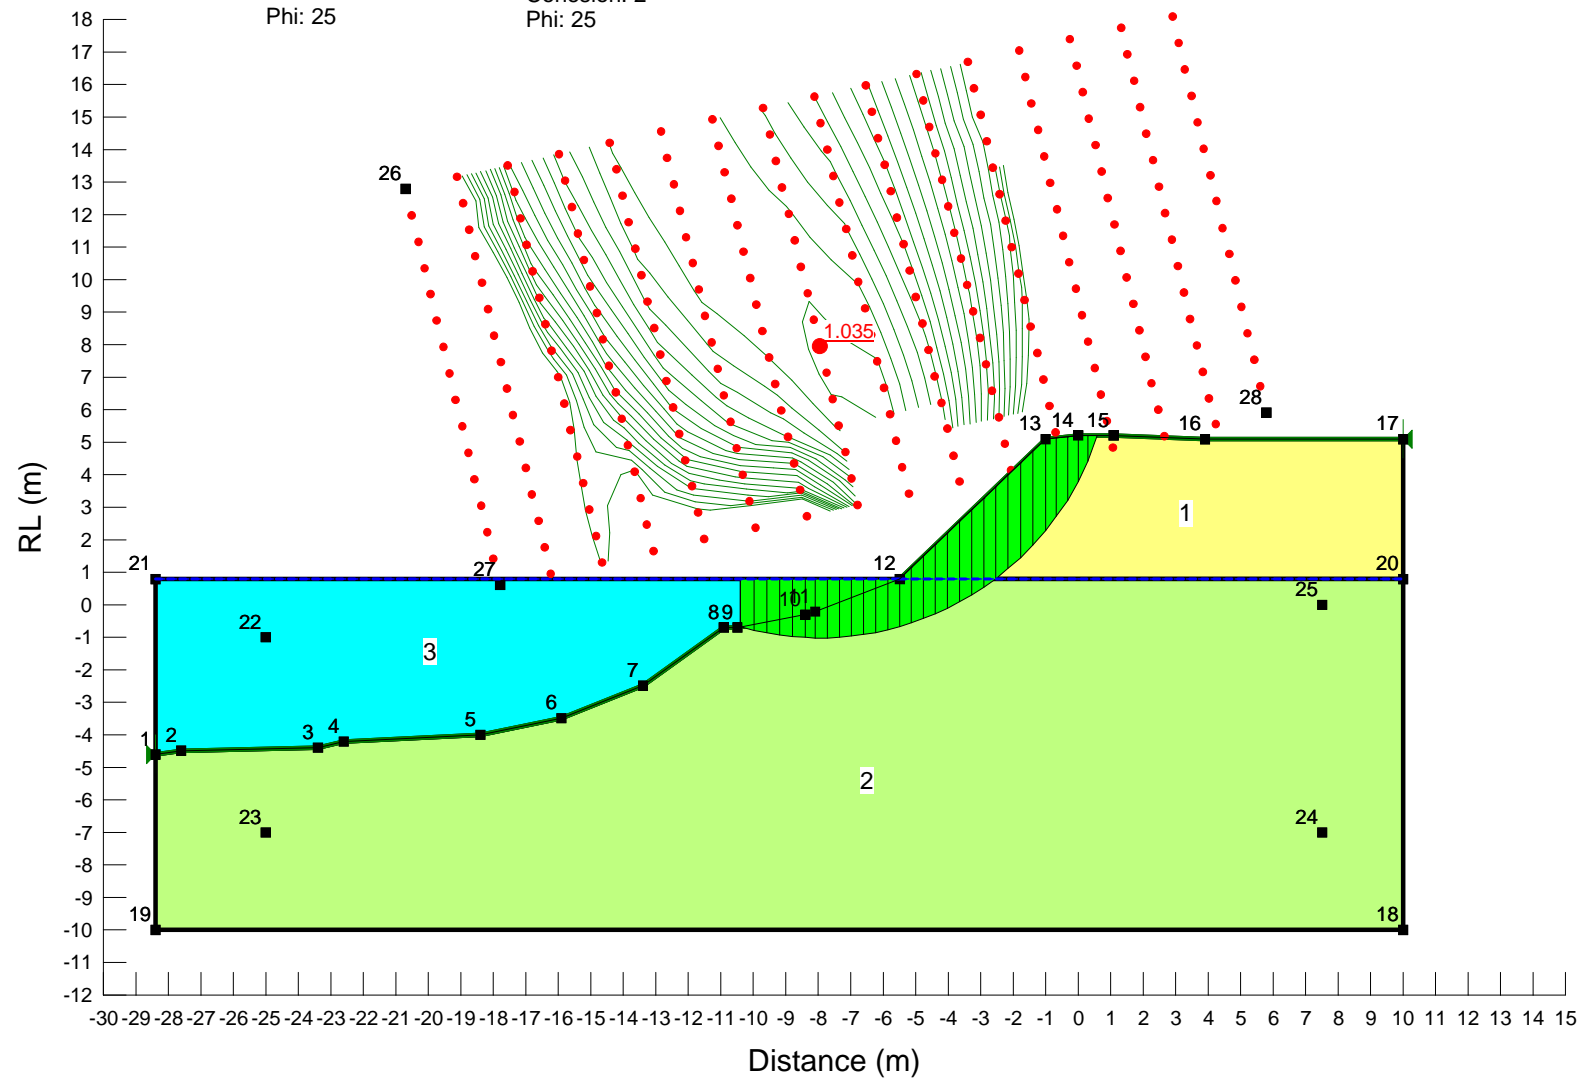
Material #: 1	Material #: 2	Material #: 3
Description: Silty Sand	Description: Silty Clay	Description: Water
Wt: 18	Wt: 17	Wt: 9.807
Cohesion: 5	Cohesion: 2	
Phi: 25	Phi: 25
