Section 19 (Figure 19.2)
Case 2 : Water Table at RL +5.1m with short term parameters

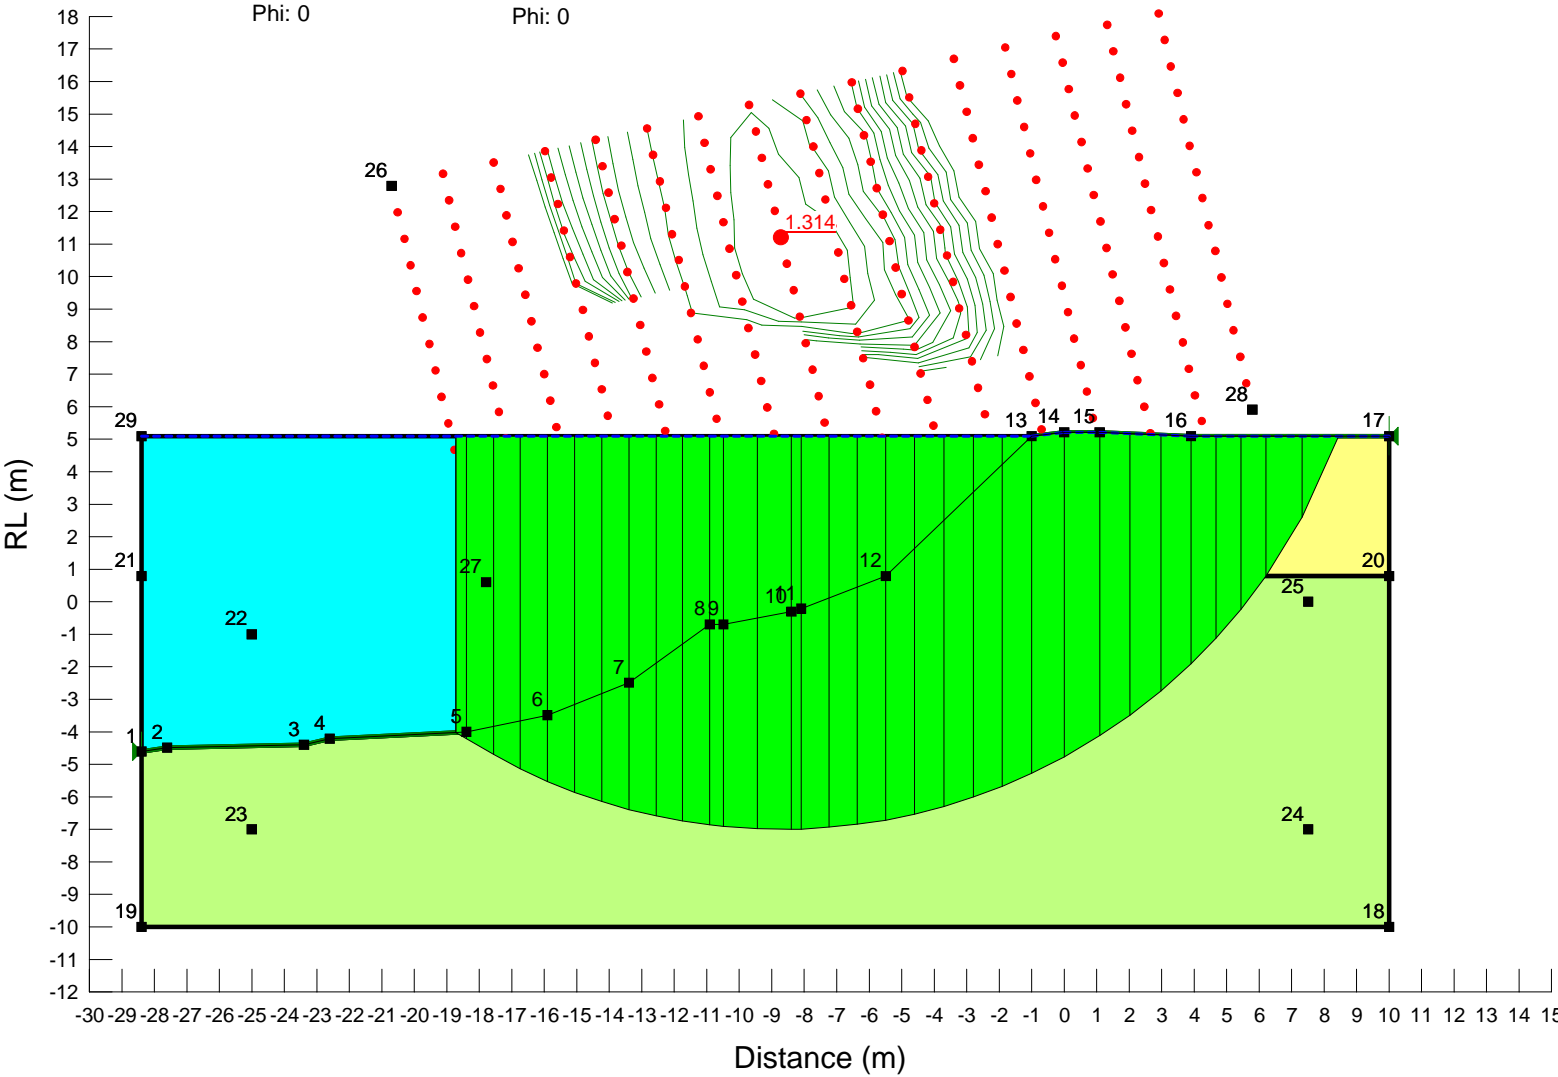
Material #: 1	Material #: 2	Material #: 3
Description: Silty Sand	Description: Silty Clay	Description: Water
Wt: 18	Wt: 17	Wt: 9.807
Cohesion: 12	Cohesion: 15	
Phi: 0	Phi: 0
