Section 8 (Figure 8.2)
Case 2 : Water Table at RL +4.3m with Short Term parameters

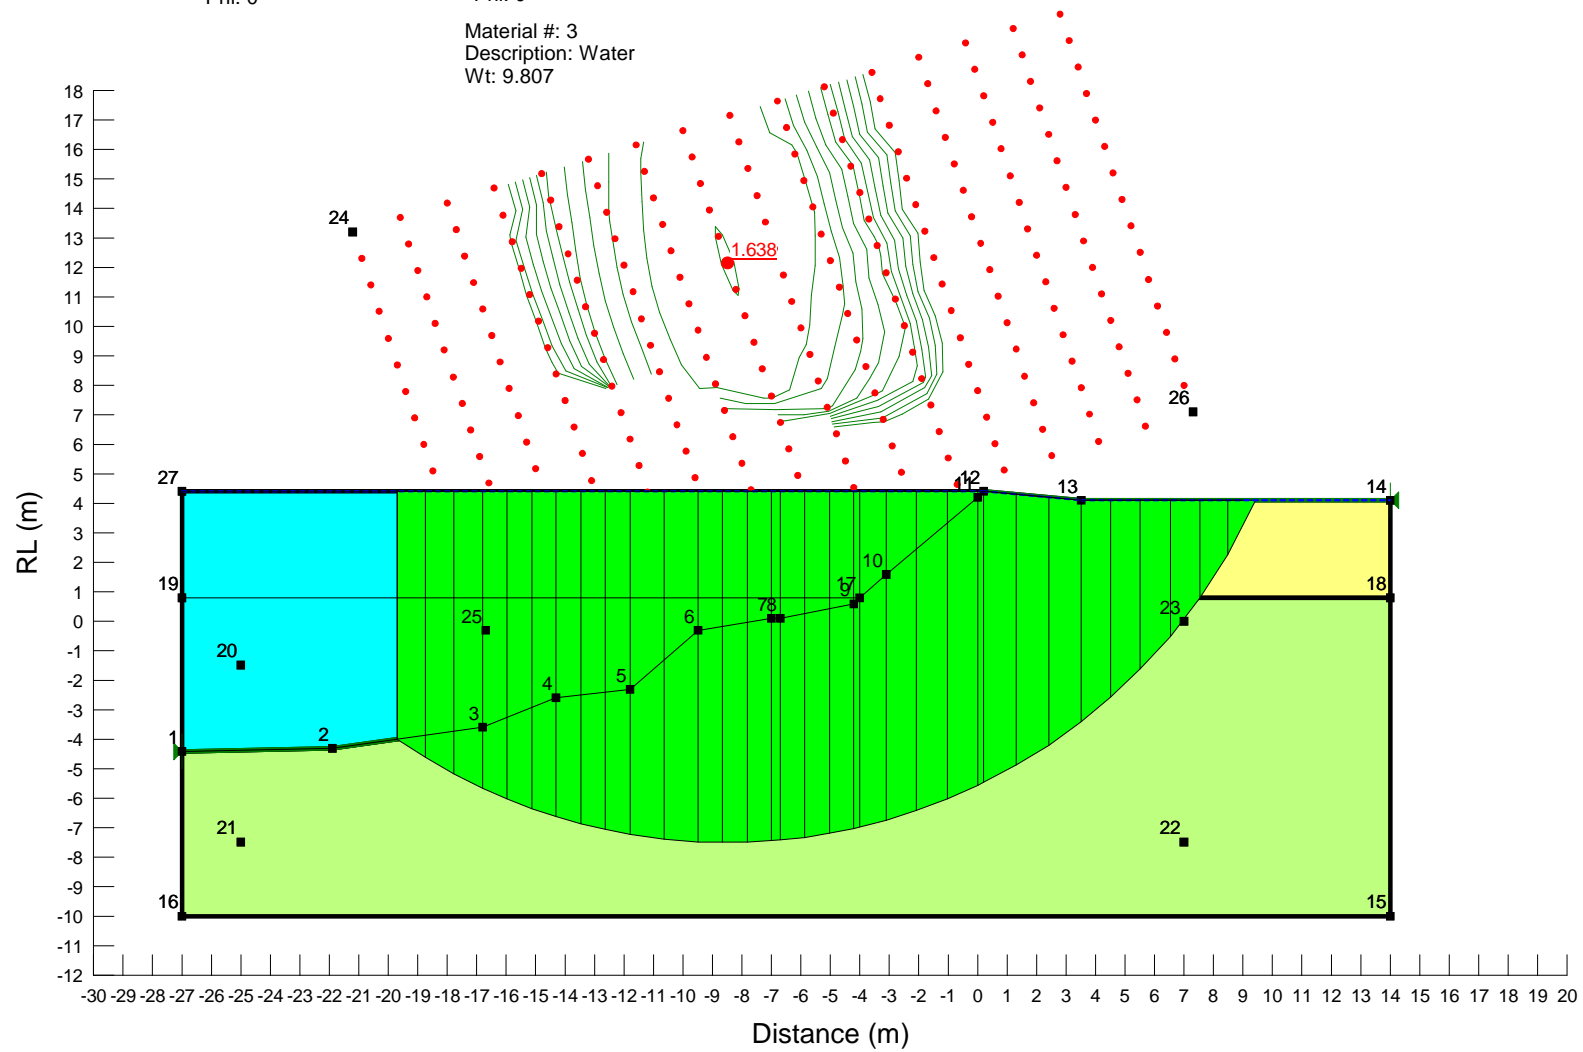
Material #: 1	Material #: 2
Description: Silty Sand	Description: Silty Clay
Wt: 18	Wt: 17
Cohesion: 12	Cohesion: 15
Phi: 0	Phi: 0
	Material #: 3
	Description: Water
	Wt: 9.807
